The Investigation and Monitoring of Coastal Landslides at Barton on Sea, Hampshire, UK

DS Fort, AR Clark, DG Cliffe, High Point Rendel, London, UK

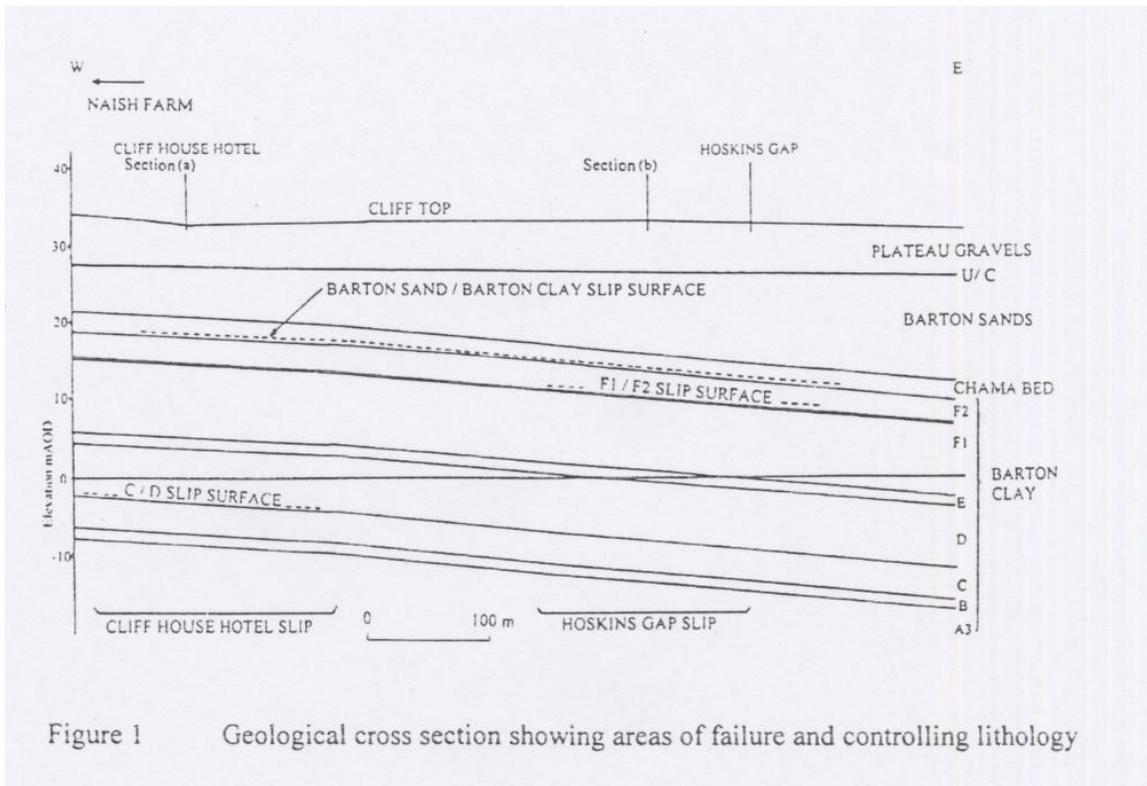
exposed to wave attack and significant erosion at the toe of the slope. This process has promoted the development and characteristics of the landslides along this coastline (Figure 1).

Slope instability has been observed within the undercliff for many years with major slope failures being recorded in 1974 and 1987/88 just east of Hoskins Gap and below the Cliff House Hotel in 1993 and 1998 (See Figure 1). Large scale instability of the undercliff continued to become evident in the winter 1992/93 and became more extensive throughout the remaining 1990s. Localised failures, especially of the lower slopes, have historically been widespread, requiring extensive treatment by ground replacement and shallow drainage.

Figure 1 Geological cross section showing areas of failure and controlling lithology

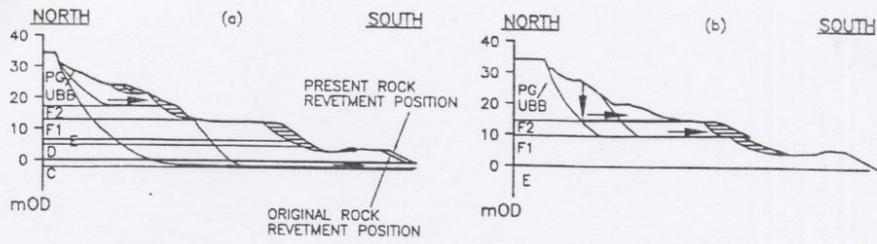
The recent geomorphological mapping, ground investigation and monitoring has shown that a number of failure mechanisms are operating within the undercliff. The main mechanisms of instability are illustrated in Figure 2 and are described below:

- i) **COMPOUND FAILURE SYSTEM** involving non rotational failure seated along near horizontal translational shear surfaces at a number of lithological boundaries within the Barton Beds. This type of failure involves the lateral displacement of a block to form an elongated ridge parallel to the cliff and the creation of a graben immediately upslope of the failed block. This also results in the failure of narrow wedges of the upper cliff.

Throughout the Barton undercliff a translational surface exists on the boundary between the Barton Sand and underlying Barton Clay. Deeper seated, lithologically controlled, translational failures correspond to sliding on the Barton Clay F1/F2 lithological interface below and to the west of Hoskins Gap and, at the western end of the site below the Cliff House Hotel, on the Barton Clay C/D lithological interface (Figure 1). The Barton Clay C/D slip surface passes below the rock armour placed in 1991 to outcrop in the seabed and the rock armour has been displaced seaward in this area. It is important to note that the development of these shear surfaces on either the Barton Clay C/D or F1/F2 lithological units occurs where hard bands of calcereous mudstone and nodule beds are present. It is considered that these relatively "stiff" inclusions within the clay lithology may result in the development of strain concentrations during swelling or shearing, hence resulting in the development of preferred slip planes.

- ii) **SHALLOW TRANSLATIONAL MUDSLIDE FAILURES** principally developed within the Barton Clay, but also within the previously failed colluvial material. These are relatively slow moving masses of clay rich debris sliding on translational shear surfaces, often partly along lithological boundaries.
- iii) Reactivation of previous slips partially stabilized by replacement of slip debris with limestone quarry run material and rock fill.

Figure 2 Mechanisms of slope failure; a) below Cliff House Hotel and b) west of Hoskins Gap

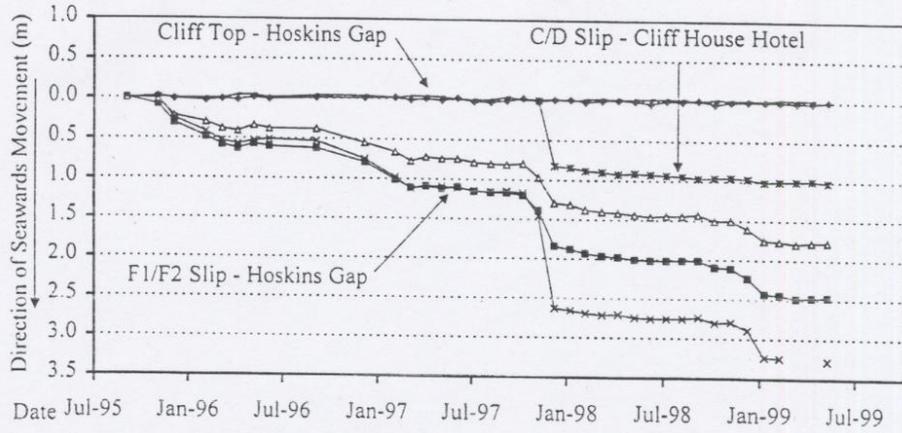
Results from monitoring of instrumentation described above show clear relationships of ground movement with the onset of the wet winter period (Figure 3). A comparison of monthly rainfall with ground movement has been made for those monitoring points that show significant seasonal trends in movement. Monthly rainfall records and antecedent rainfall for between 1994 and 1999 are presented in Figure 4 which also shows the start and end of significant ground movement for selected locations derived from borehole inclinometer data and topographic surveys. Ground movement for the winters 1994/95 to 1998/99 generally start to accelerate during October/November. The rapid response between the onset of winter rainfall and ground movement is probably a reflection of the relatively high soil permeability of the ground.

Figure 3 Typical surface ground movement monitoring results

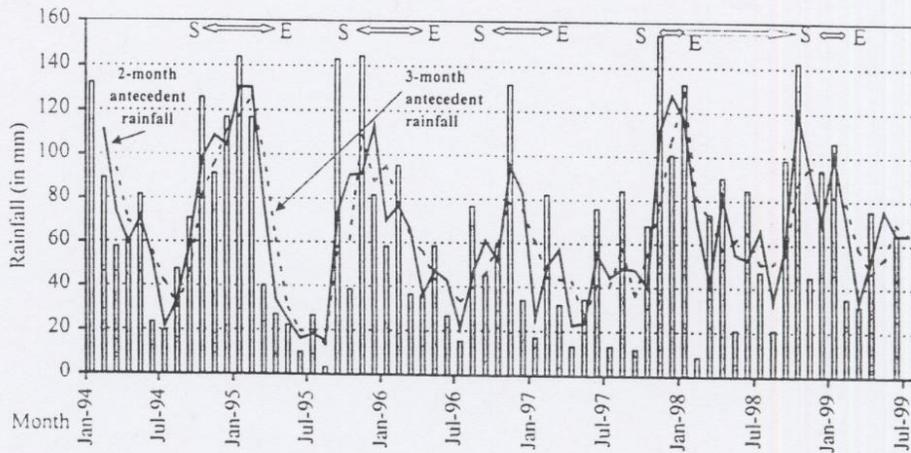
Accelerating ground movements in October/November generally appear to commence when monthly rainfall for the average current and preceding months (antecedent 2 month average) is in excess of about 80mm/month. The onset of ground movement in

October/November 1996 however appears to have initiated at a lower average rainfall threshold of about 55mm/month. Once high rates of movement have commenced during the winter period, monthly rainfall has to reduce to relatively low levels for rates of ground movement to reduce back to summer levels with average monthly rainfall typically being about 40mm to 50mm.

Figure 4 Relationship of start (S) and end (E) of ground movement with rainfall
